SUB-COMMITTEE ON SAFETY OF
NAVIGATION
52nd session
Agenda items 10 and 12

PERFORMANCE STANDARDS FOR SHIPBORNE GALILEO RECEIVER EQUIPMENT

J54-05-016

**RESULTS OF
COMMERCIAL GLOBAL POSITIONING SYSTEM (GPS) ANTENNA
ELECTROMAGNETIC VULNERABILITY TESTS**

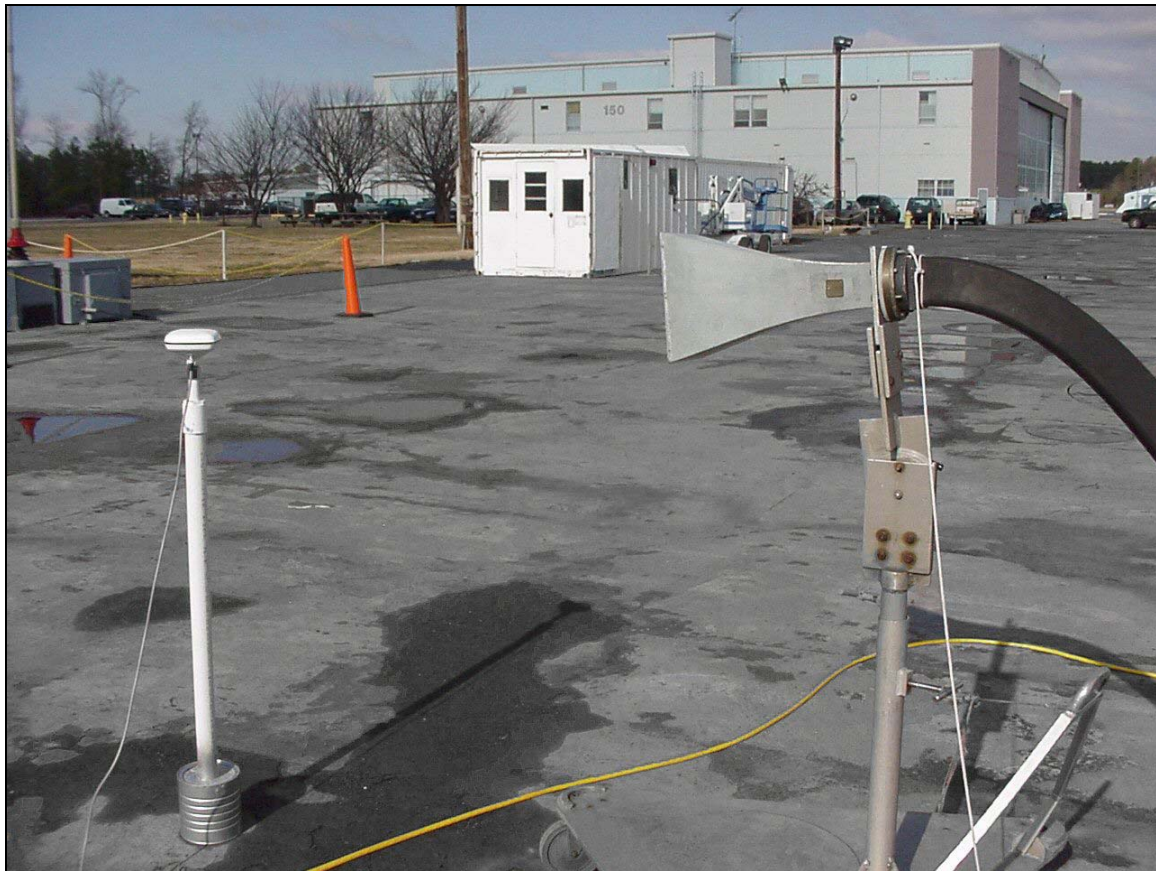
Figure 1. S-Band Antenna Radiating GPS Antenna

The listed antennas in Table 1 were subjected to the parameters specified in Table 2. Tables 3 through 7 describe how the antennas responded to the respective parameters. Figure 1 shows an antenna being tested at the power densities described in Tables 3 through 6. Figure 2 shows the L-Band antenna used in the L-Band test described in Table 7.
