# Application of AtoN Telematics for Structural Health Monitoring

Aivar Usk, Cybernetica AS

Per Erik Ose, Norwegian Coastal Administration

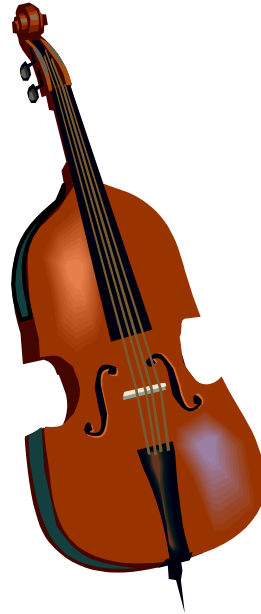
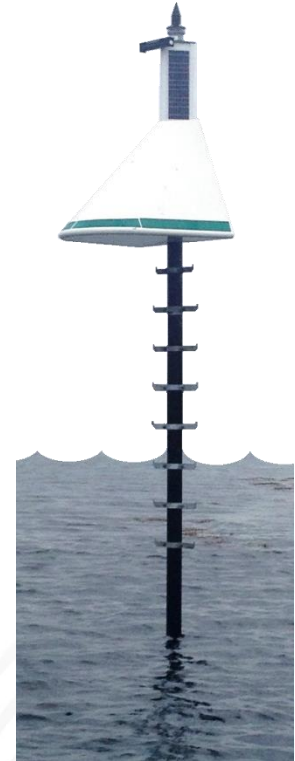
# Natural Frequency Appears When Excited

The resonance frequency depends on mass, stiffness and damping: dimensions, materials, weight, temperature, etc

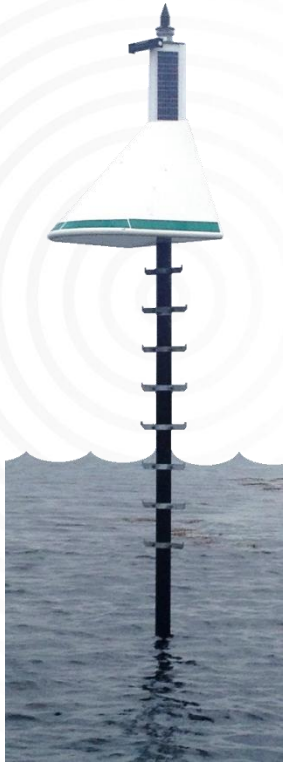
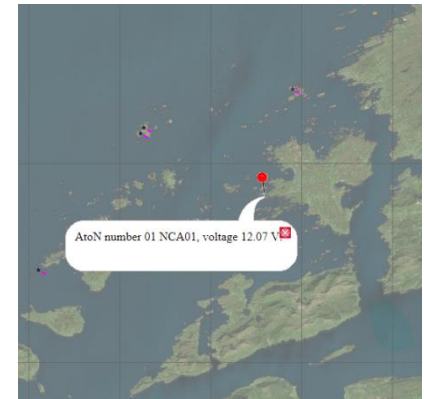
# NCA01: Dirigens Lux AtoN at Småge

- Height 7.5 m above sea level, 2 m under water (high tide)
- Weight 100 kg
- Mount: embedded in seabed (or rock)
- Bearing structure: Ø 140 mm composite rod
- Type: Test object for a new maintenance free large composite HIB AtoN design

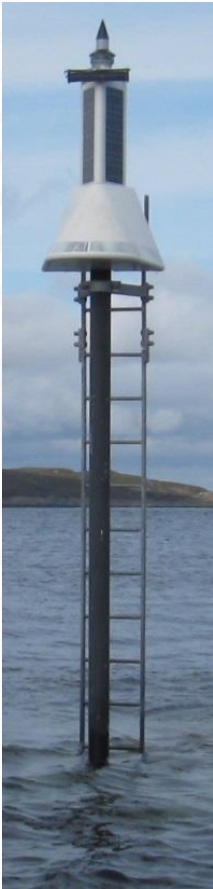
# NCA02: Dirigens Mini AtoN at Sandøy

- Height 6.5 m above sea level, 0.5 m below (high tide)
- Weight 60 kg
- Mount: embedded in seabed (or rock)
- Bearing structure: Ø 140 mm composite rod
- Type: Test object for a new maintenance free small composite HIB AtoN

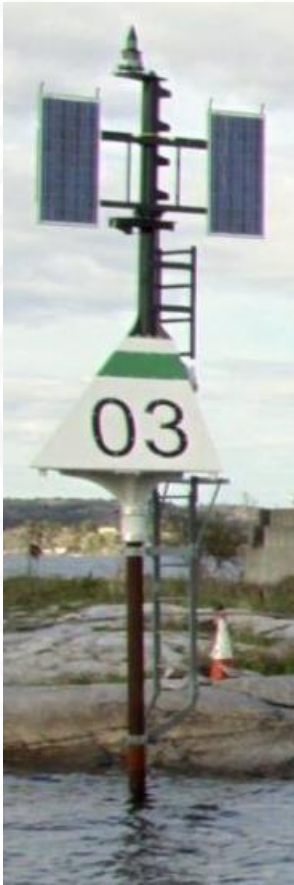
# NCA03: Original HIB AtoN at Nørve

- Height 8.5 m above sea level, 1.5 m below at high tide
- Weight 500 kg
- Mount: embedded in seabed (or rock)
- Bearing structure: Ø 140 mm steel rod
- Type: Test object for the initial HIB design, large metal structure

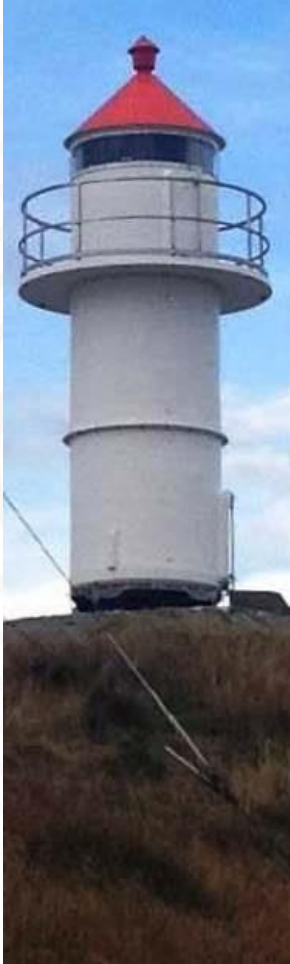
# NCA04: Lighthouse at Husøyvågen, Ona

- ⊙ Height 8 m above ground
- ⊙ Weight 1500 kg
- ⊙ Mount: 4 x threaded rods 48x1000 VZN
- ⊙ Bearing structure: Composite GRP

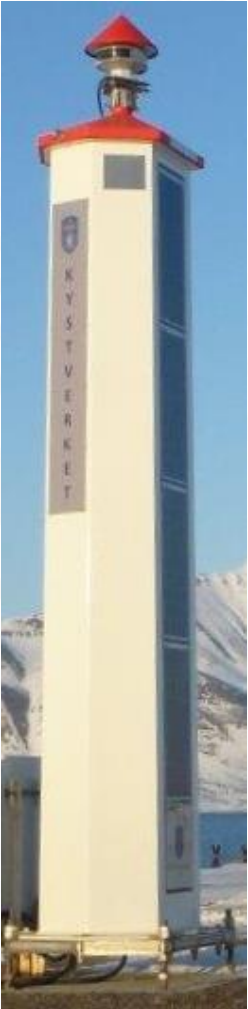
# NCA05: Litus Lux Lighthouse on Svalbard

- Height 6.5 m
- Weight 500 kg
- Mount: 4 threaded rods 48x1000 VZN
- Bearing structure: Ø 800 mm Glass fiber reinforced vinylester with a core of Divynccell
- Type: Test object for a new maintenance free generation of composite Lighthouses
