Australian Maritime Safety Authority

Recent modifications and upgrade projects within the AMSA network

Greg Hansen – BE (Marine & Offshore Systems) Honours - CEng CMarEng MIMarEST

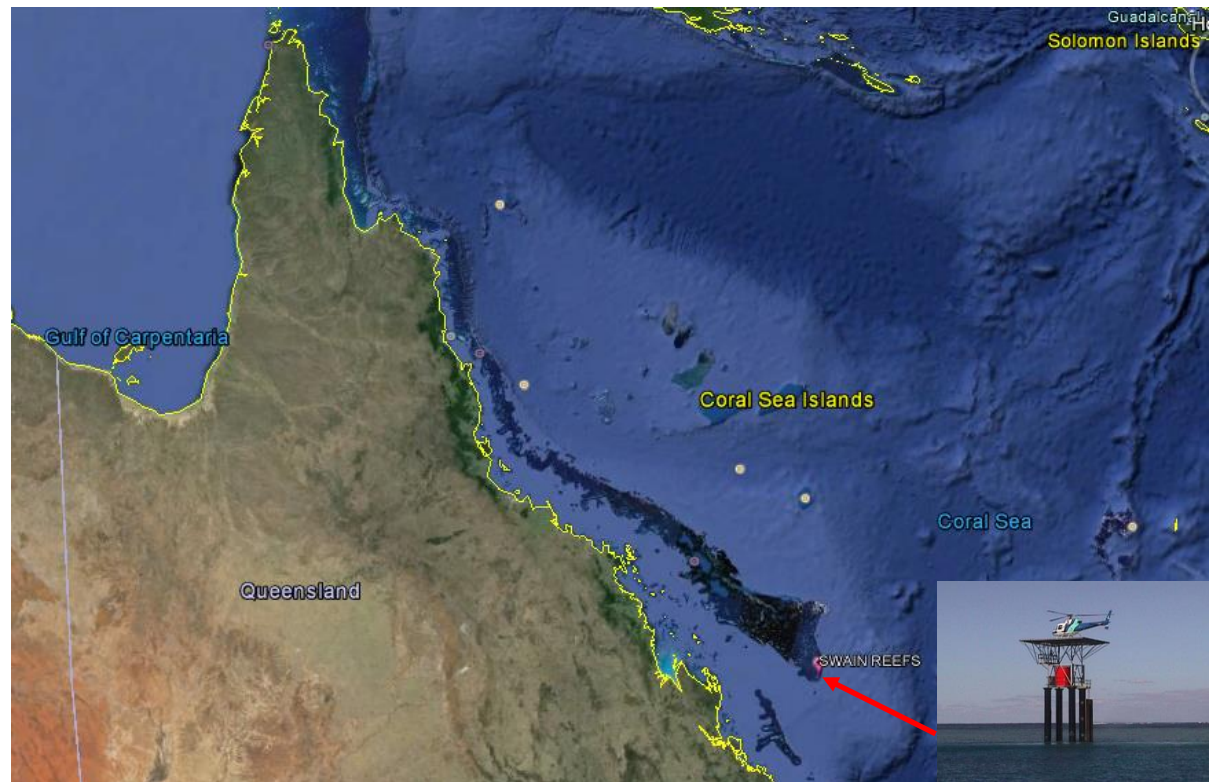
- ▶ Swain Reefs AtoN structure
- ▶ 130nm from the mainland coast
- ▶ Constructed in 1999
- ▶ Helipad damaged by a cyclone and removed in 2010
- ▶ Height increased in 2014

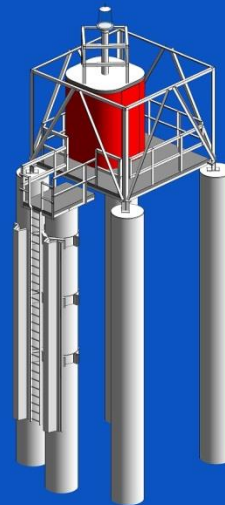
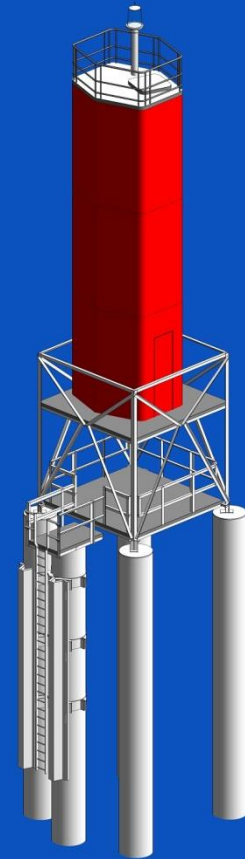
- On existing piles a 3m stainless steel lattice framework section with a 3 module hex tower on top.

- 10m elevation (existing)
- Final height 20m

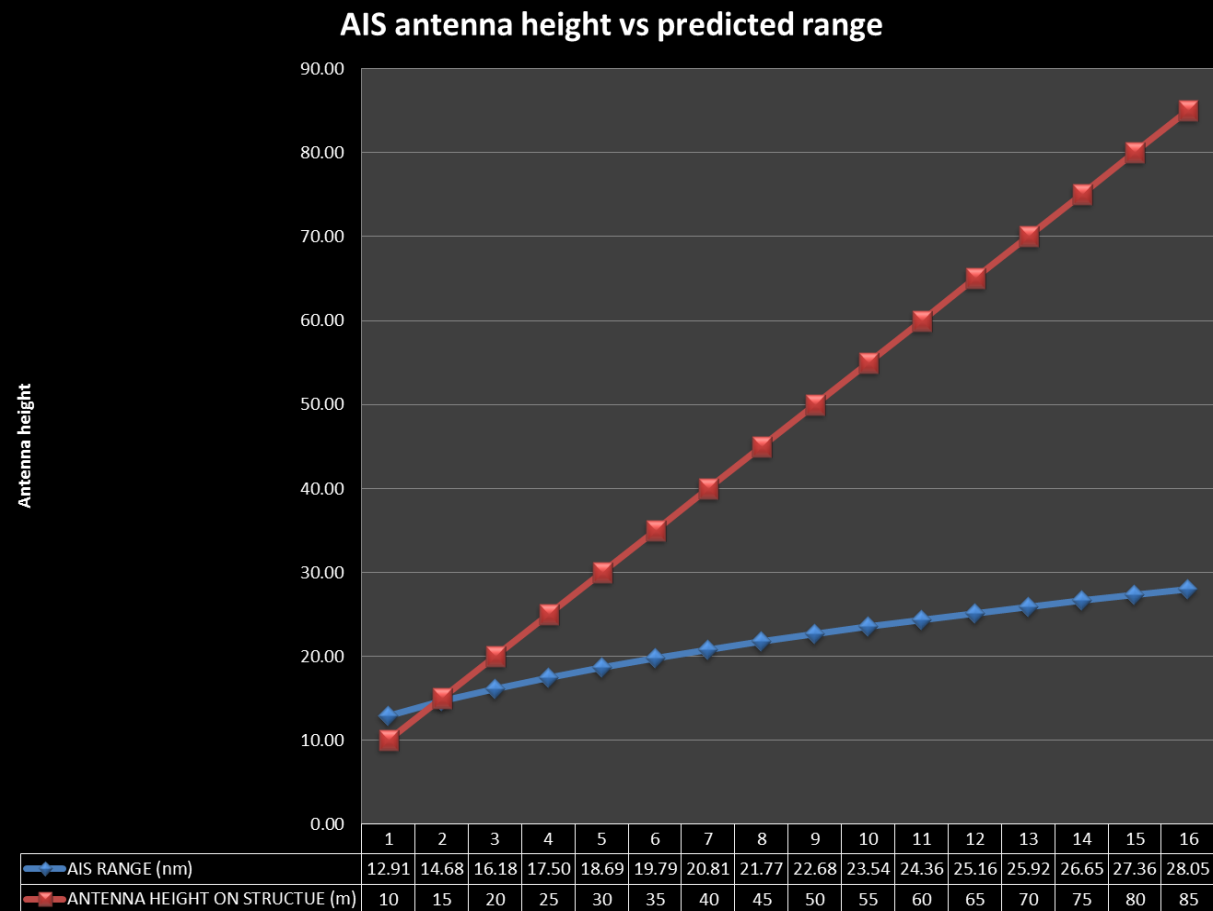
- ▶ Using IALA AIS range formula to predict range vs antenna height

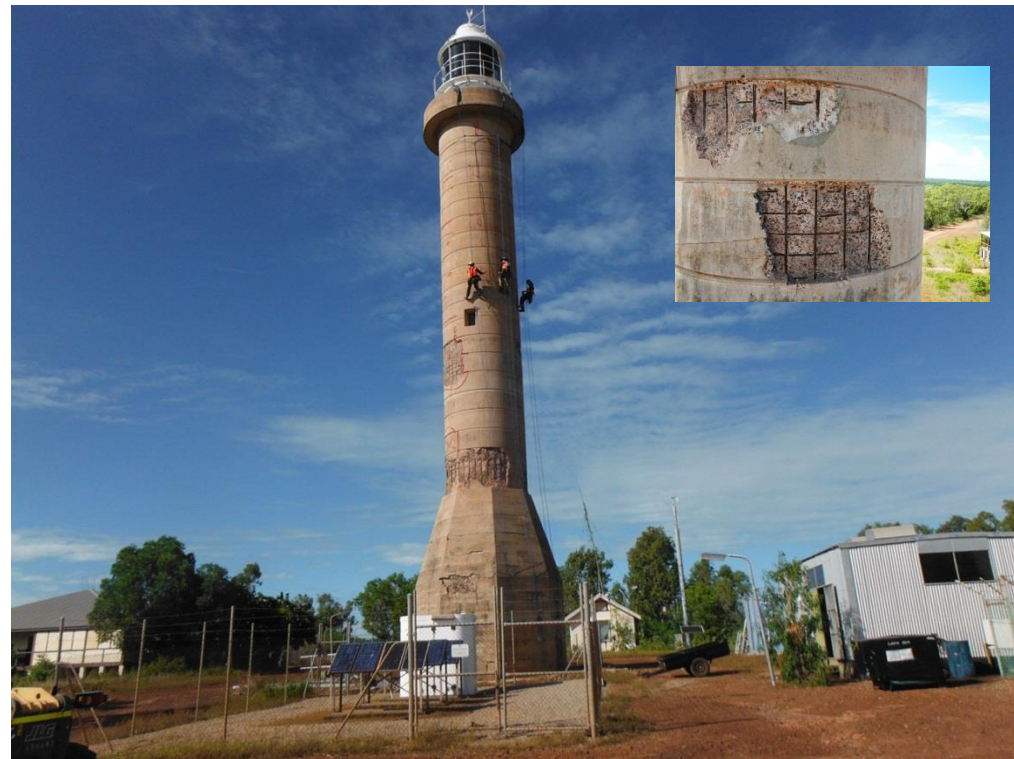
- ▶ Cape Don Lighthouse
- ▶ Reinforced concrete built in 1916.
- ▶ Issues causing cracking and delamination included Alkali Silica Reaction (ASR), carbonation and Chloride contamination.

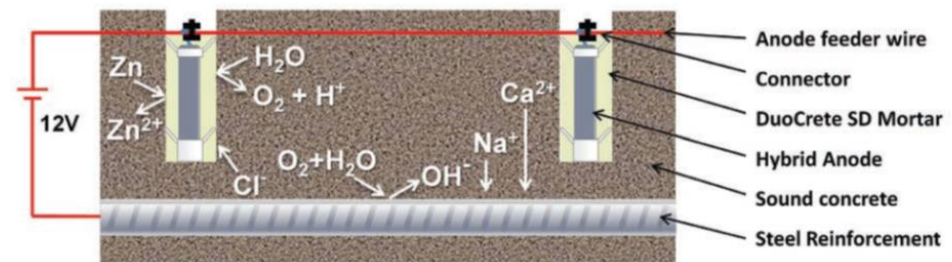
Short-term Impressed Current

- Duoguard Hybrid Anode system with a fifty year design life.
- Phase 1 – short term (7 days) impressed current phase.
- Phase 2 – long term galvanic protection.

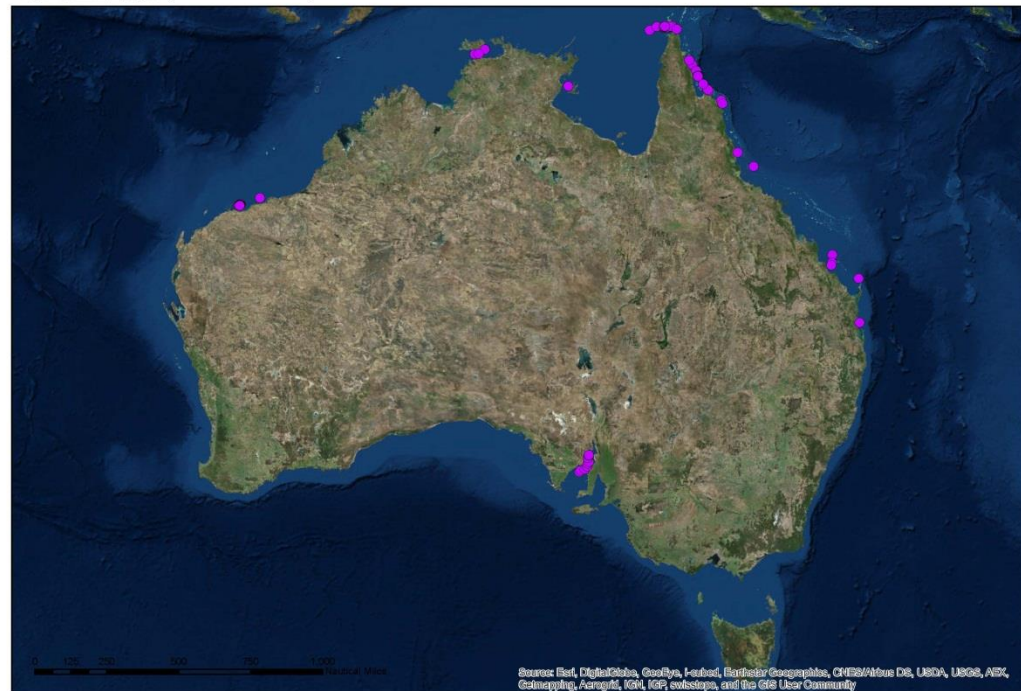
- ▶ Buoy network
 - ▶ 63 ocean buoys
- ▶ Replacing all steel buoys with polyethylene\
- ▶ MOBILIS Jet 7000 with high vis towers
- ▶ Timeframe within 3 years
